**FINAL
FOUNDATION
REPORT**

**AMISTAD POWERPLANT
DEL RIO, TEXAS**

OCTOBER 1983

ALAN J. MARR

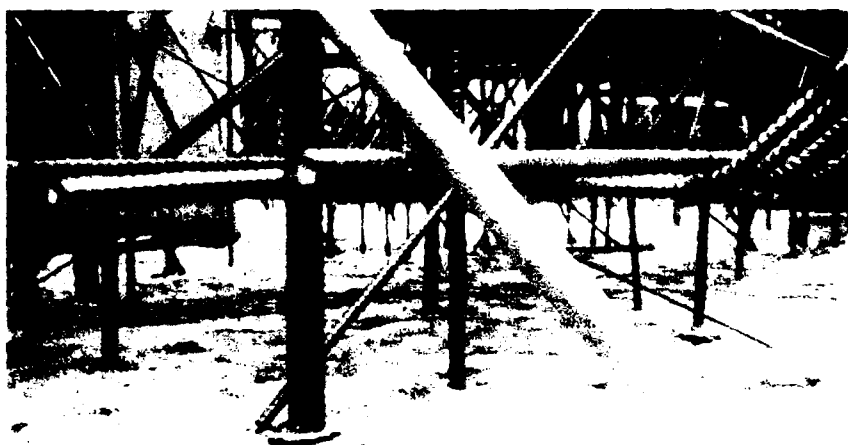
2. Foundation Surface. After final shaping and cleanup, the limestone foundation surface exhibited varying degrees of unevenness. Where final grade occurred along one of the horizontal shaly seams within the formation, the soft shaly material within the seam was removed leaving the finished limestone surface relatively flat. This condition occurred in the generator bay foundation area at elevation 845. In most cases, however, the surface was uneven to a degree of ± 0.5 feet, due to the massive and hard nature of the limestone. In general, the characteristics of the limestone foundation surface are moderately hard to hard, gray to dark gray, very fine grained and massive. Typical limestone surfaces on which concrete was placed are shown on figures 13 through 16.

Figure 16 Typical limestone foundation surface prior to concrete placement (generator bay area at elevation 845±)
